That's the seed nobody likes [line set for ac unit](#) to talk about. A cheap **refrigerant line set** can quietly turn a perfect install into a \$640 callback before the first season is over.

## #1. Pinhole Leaks in Copper Tubing — ASTM B280 Type L Copper Prevents Early Refrigerant Loss

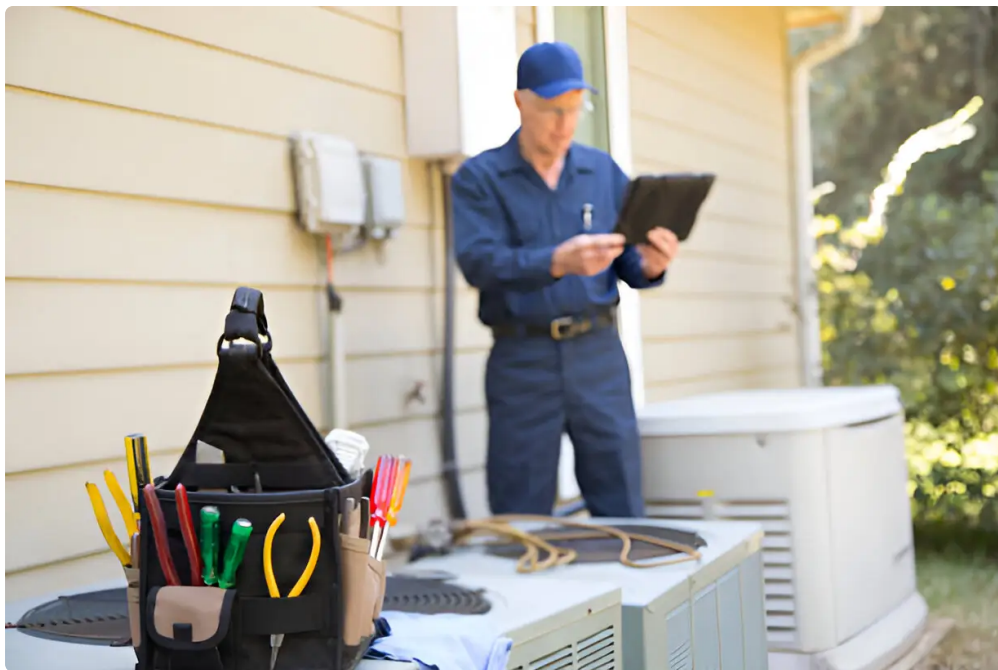
Mateo once opened a budget **ac unit line set** and found one cap loose in the carton. The copper looked clean. The micron gauge disagreed for nearly two hours.

Rectorseal-type budget sets and other import options can be tempting when the price is sharp, but shipping and storage quality matter. If end caps loosen, tubing becomes an open straw for humid warehouse air. On a July jobsite, an uncapped line can absorb moisture before lunch.

A properly capped and nitrogen-held set shortens evacuation time and reduces uncertainty. Saving even 28 minutes on evacuation, plus avoiding a return trip for a moisture-related restriction, changes the math quickly. When you factor compressor risk, refrigerant recovery, labor, and reputation, clean sealed tubing is worth every single penny.

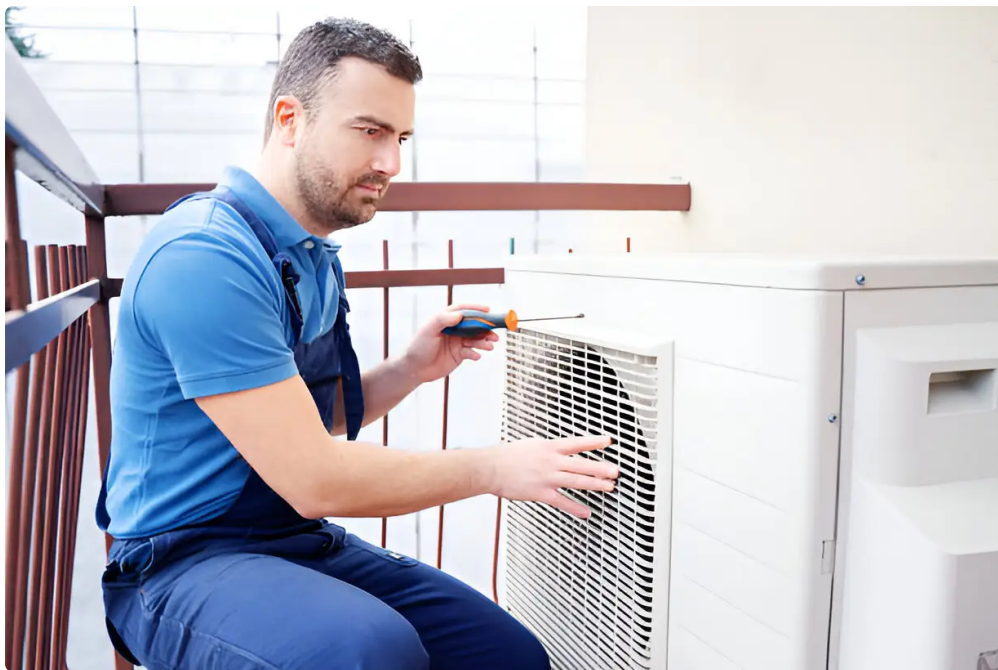
Refrigerant lines should be supported without being clamped so tightly that insulation compresses. A crushed vapor barrier invites condensation.

Long horizontal runs need consistent support. Outdoor vertical rises need protection from wind movement. At the condenser, leave enough sweep to absorb vibration without rubbing against siding, brick, or metal brackets.
